TCEQ Interoffice Memorandum

Date: September 12, 2017
Subject: TX03770 – Forest Lake Dam

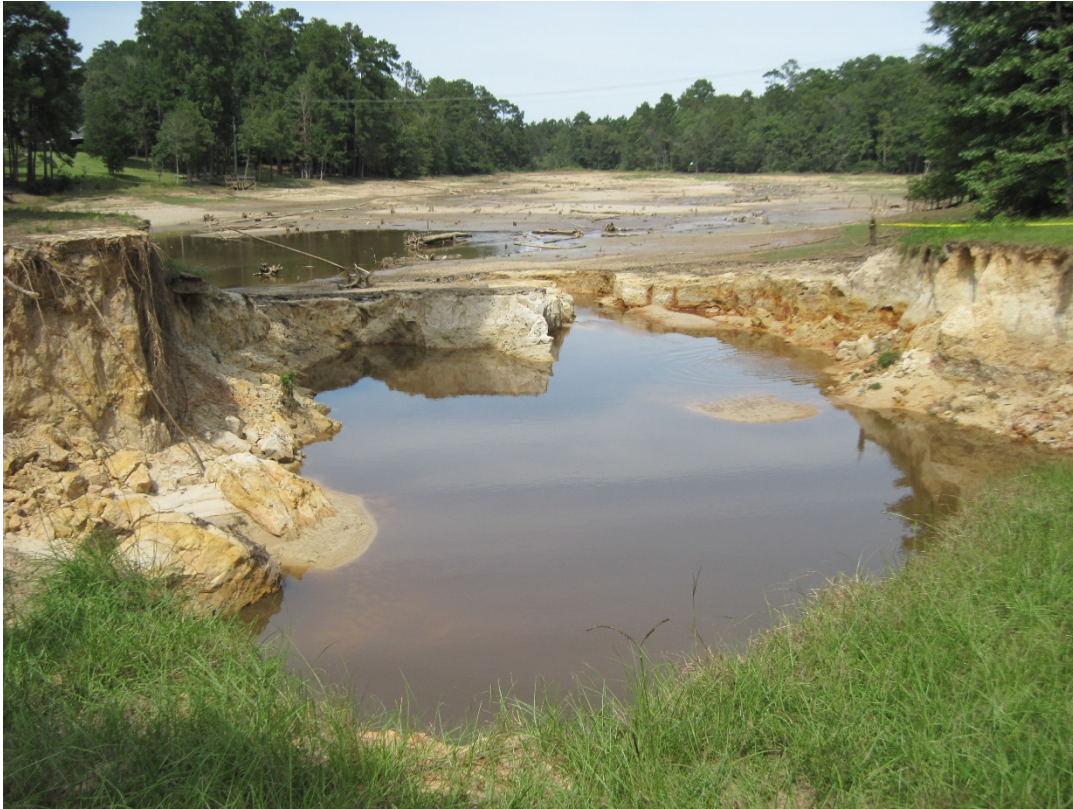
The following observations were noted as shown in the attached figure and photos: The breach was located at the left end of the dam (service spillway location) estimated at 30-Ft wide by 15-Ft high (**See Photos 1-10**). Portions of the drop-inlet spillway (48-in HDPE pipe) were carried downstream. The lake level was observed to be lowered to the approximate elevation of the bottom of the drop inlet. Large amounts of sediment were noted at the toe of the embankment and at the roadway and culvert approximately 100-Ft downstream of the dam.

Photo 1: View of breach at approximate location where service spillway was located looking northeast.

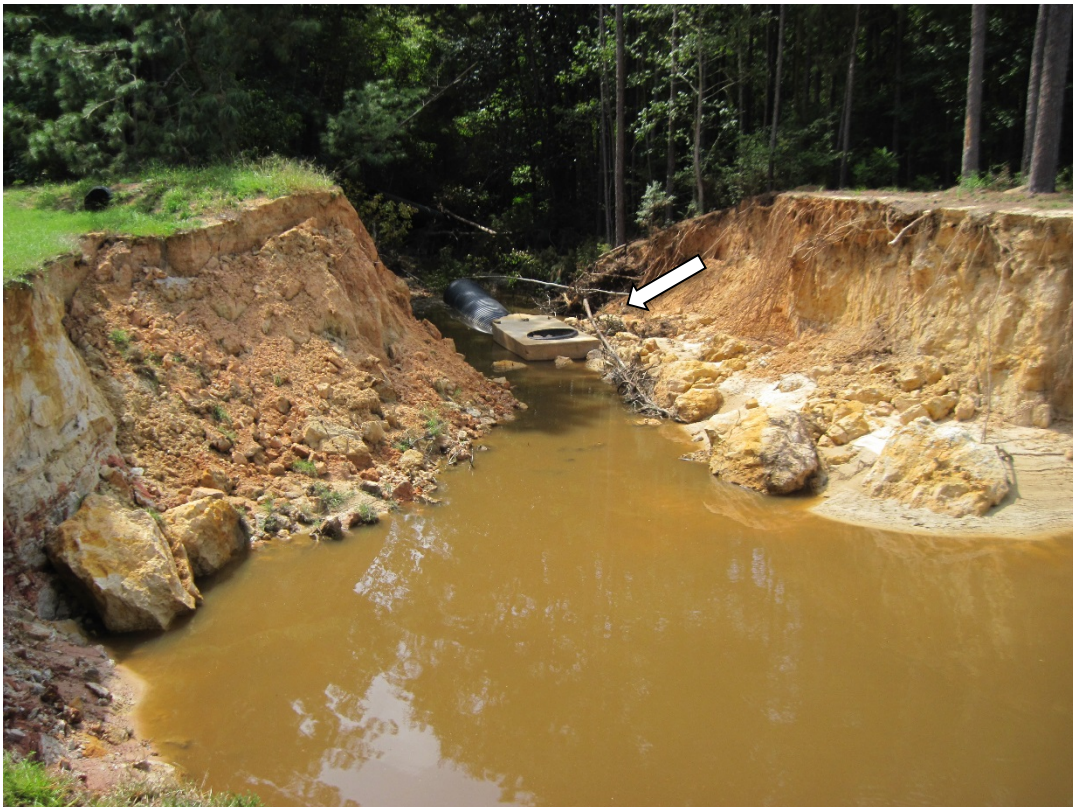
Photo 2: View of breach at approximate location where service spillway was located looking southwest. Note the concrete base and spillway outlet pipe (48-in HDPE).

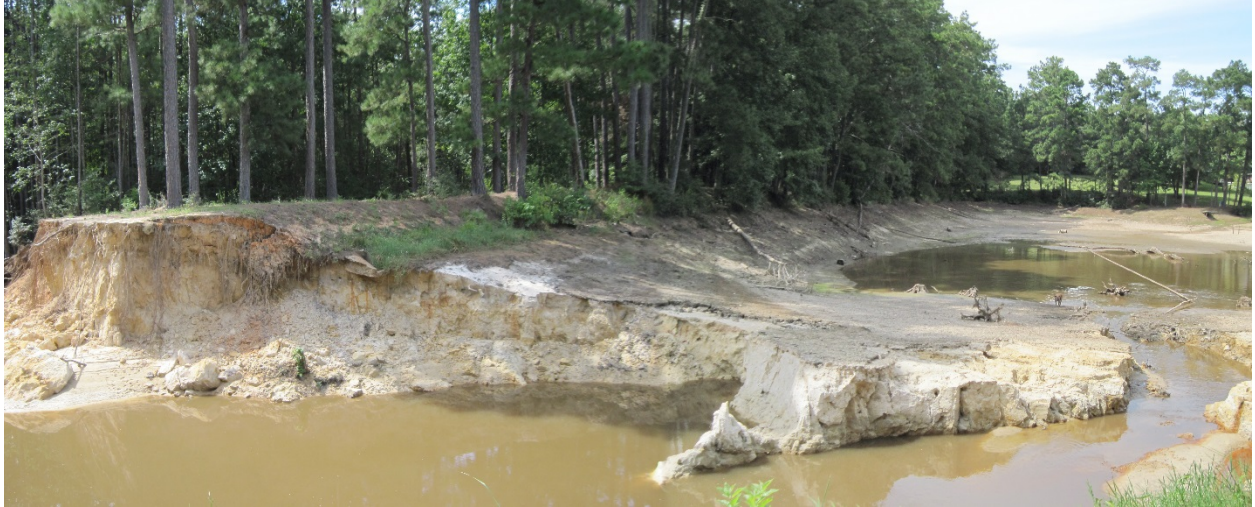
Photo 3 Panoramic view of the upstream slope and breach at the left end of the dam looking northwest.

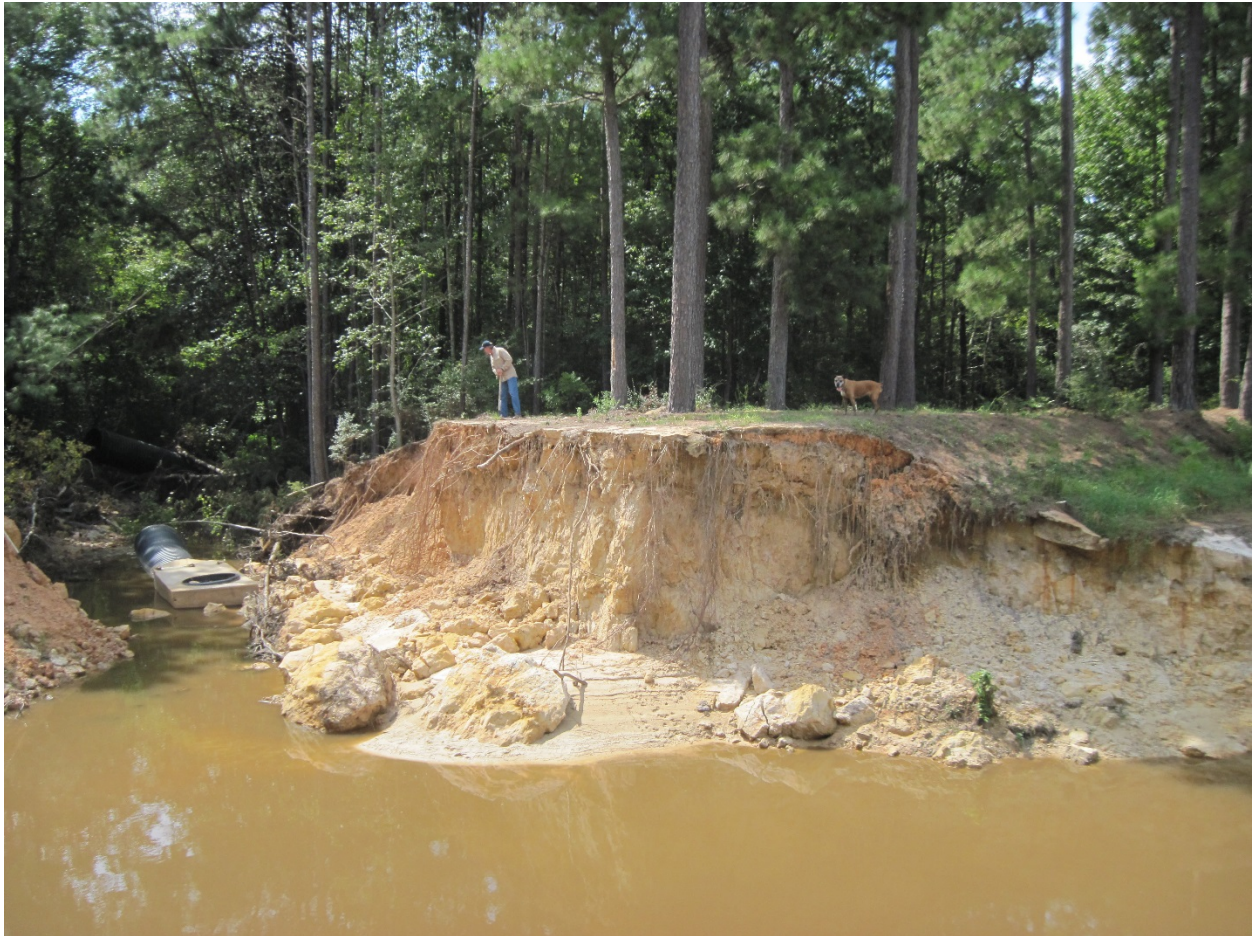
Photo 4: View of breach at approximate location where service spillway was located looking west. Note the scale and height of the breach with dog and person noted along top of the embankment (breach estimated at 15-Ft high by 30-Ft wide).

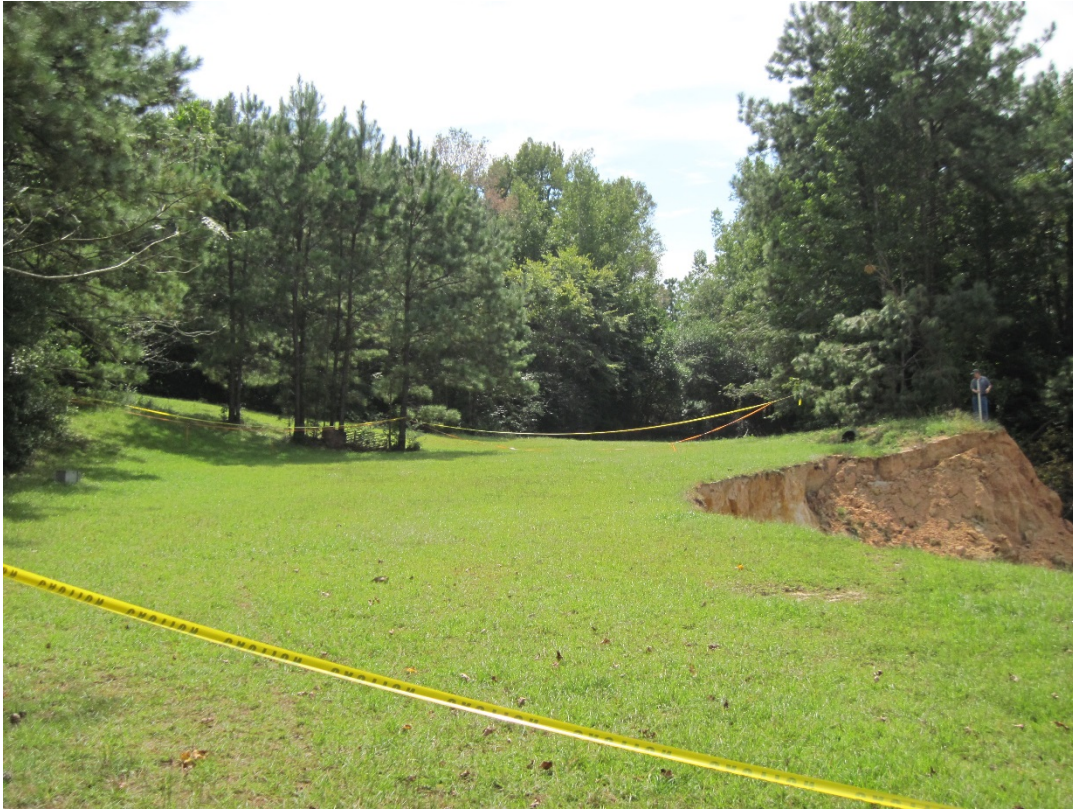
Photo 5: View of the emergency spillway looking southwest. Note the grassy area (emergency spillway) held up and the breach occurred to the right of this area.

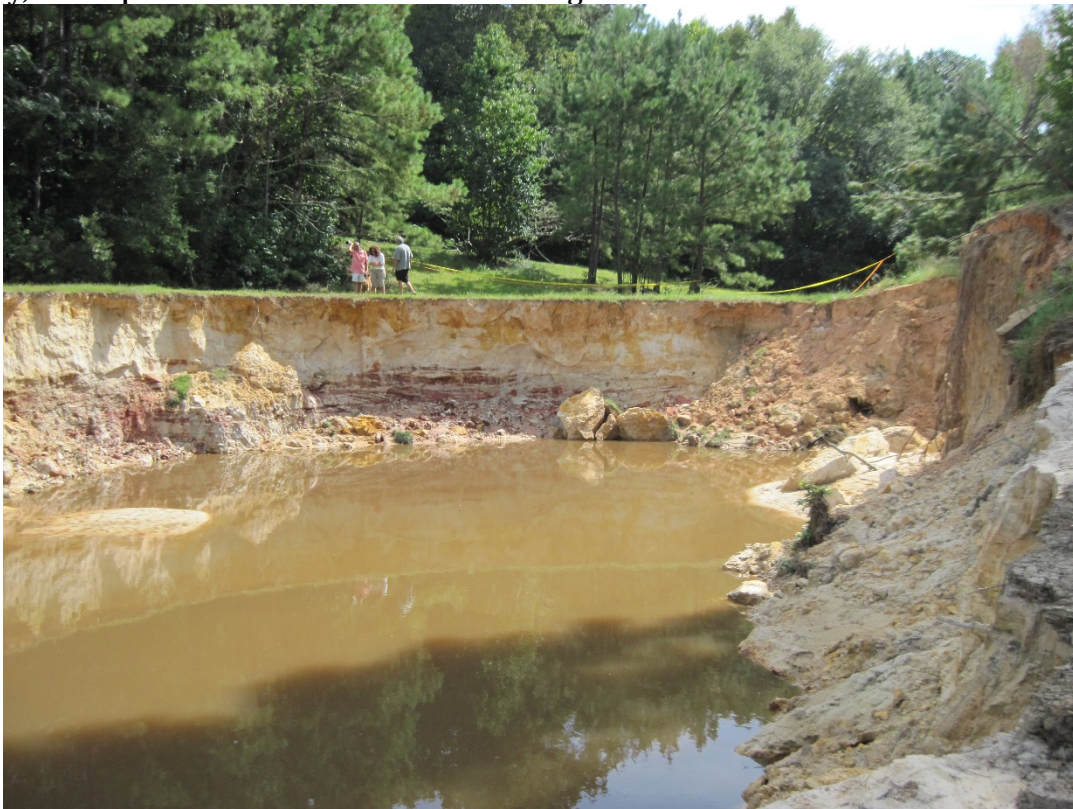
Photo 6: View of breach looking southeast. Note the scale and height of the breach with people along top of the emergency spillway area.

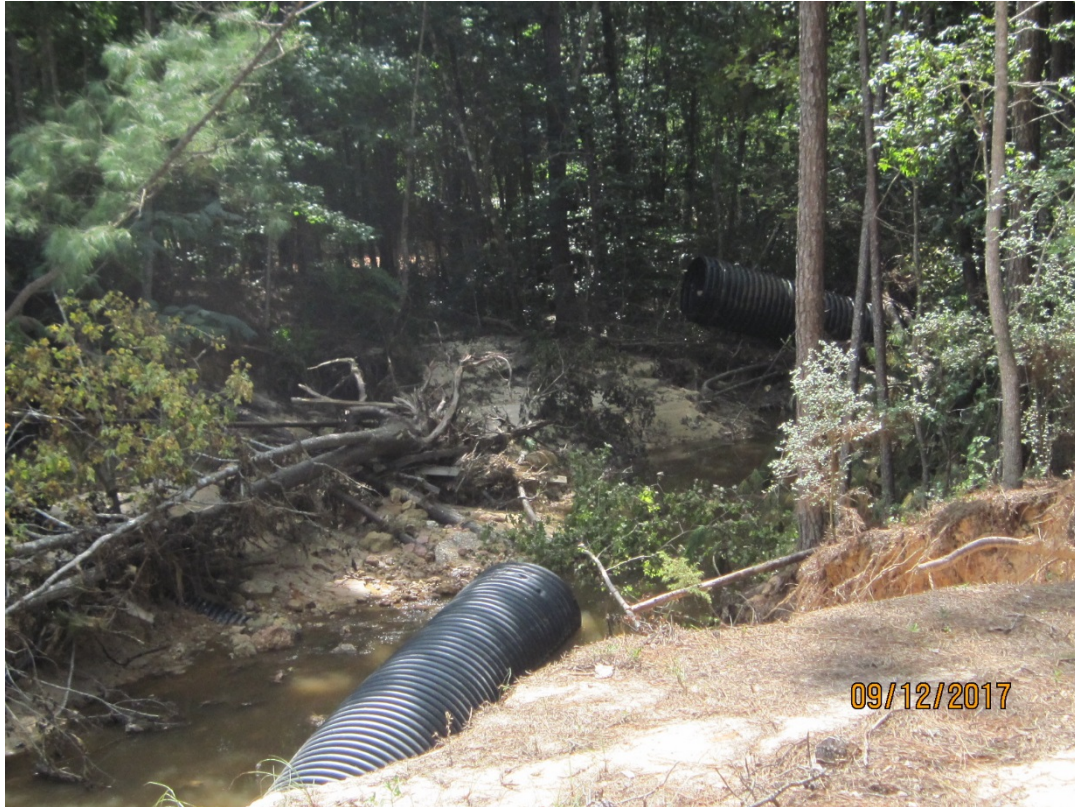
Photo 7: View downstream of the service spillway looking southwest. Note the spillway pipes carried downstream as a result of the breach.

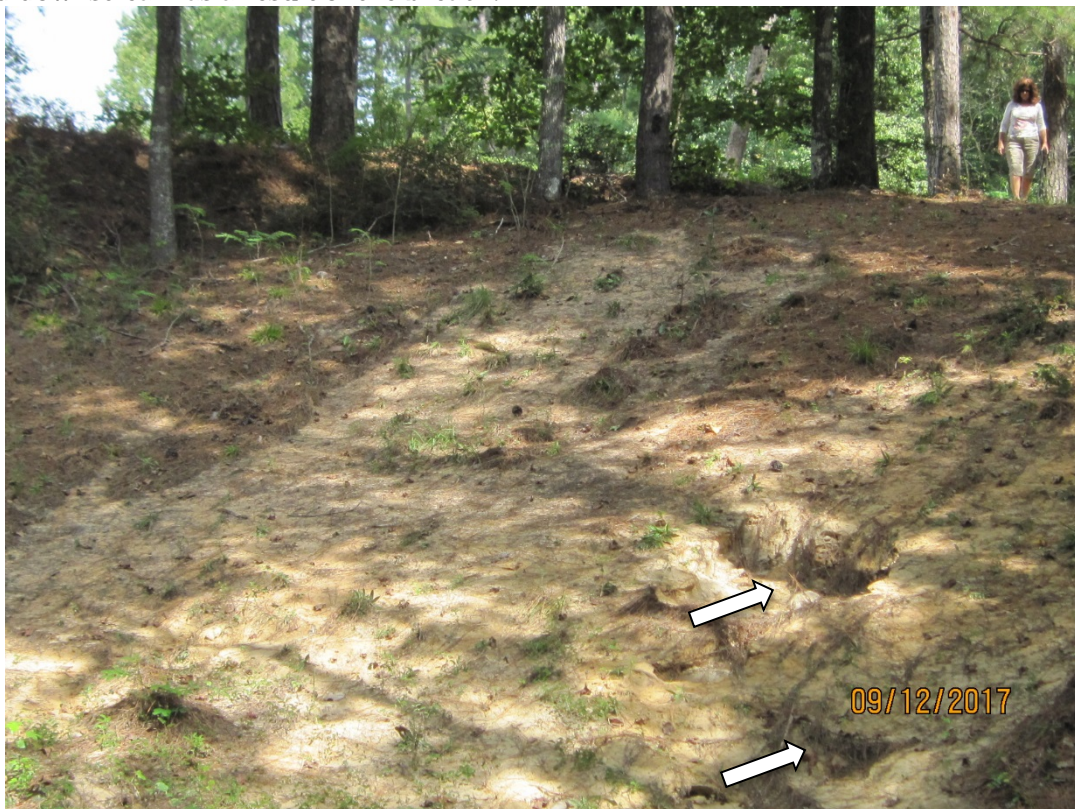
Photo 8: View of the downstream slope looking east. Note this area was overtopped as noted by the matted grass and minor areas of erosion (arrows) from scour.

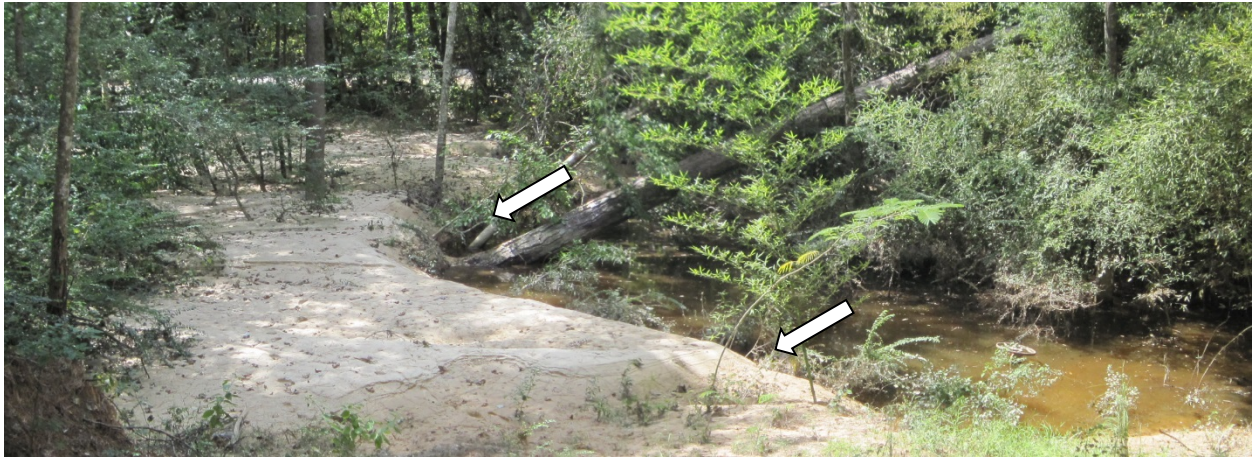
Photo 9: Panoramic view of the downstream toe and area beyond the slope looking west. Note the large amount of sediment (arrows) that was deposited downstream of the embankment.

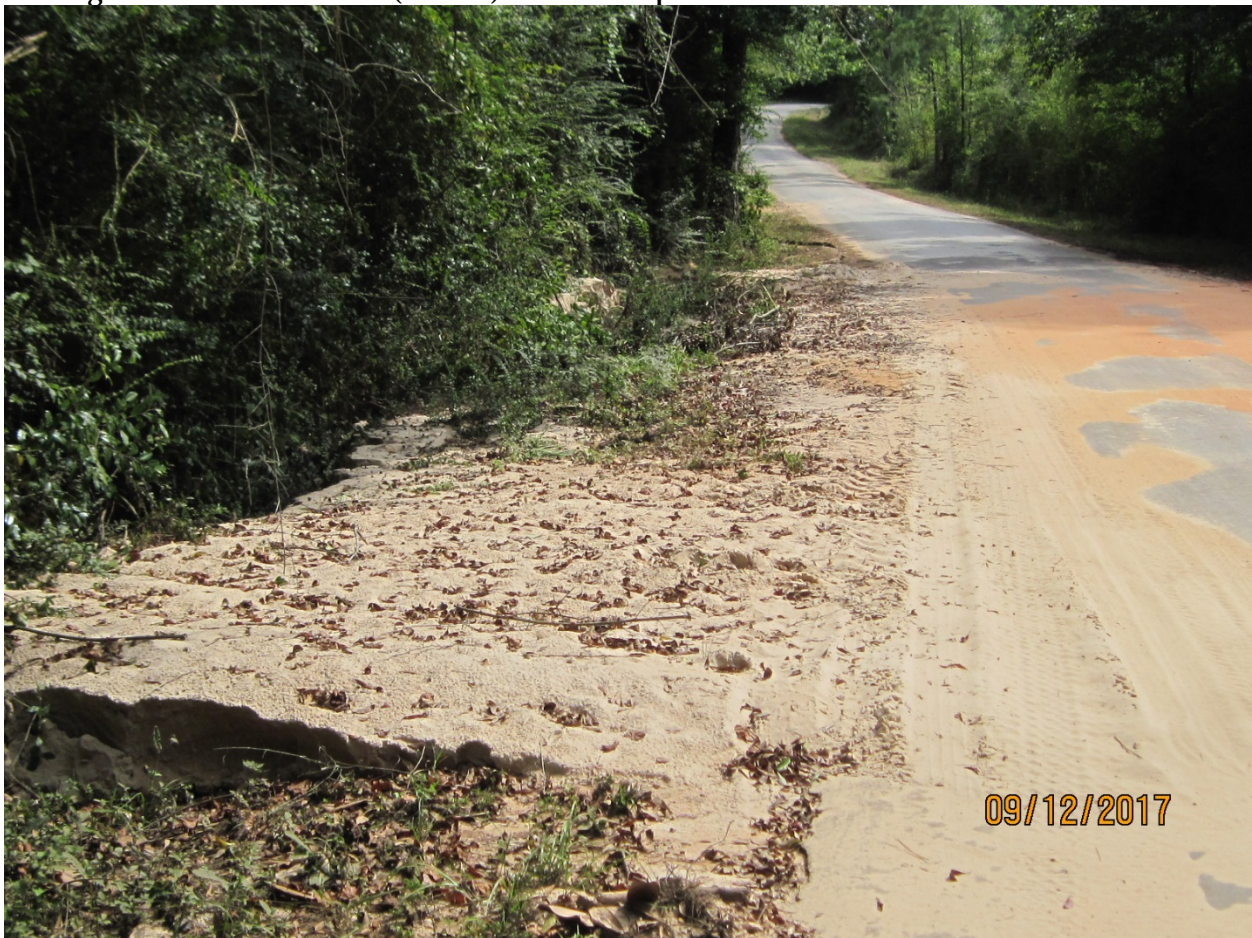
Photo 10: View of the roadway (Carlow Road) approximately 100-Ft downstream of the dam. Note the sediment that was deposited on the roadway.
